AIRCRAFT ACCIDENT REPORT

PAN AMERICAN WORLD AIRWAYS, INC
BOEING 707-121, N709PA
NEAR ELKTON, MARYLAND
DECEMBER 8, 1963

SYNOPSIS

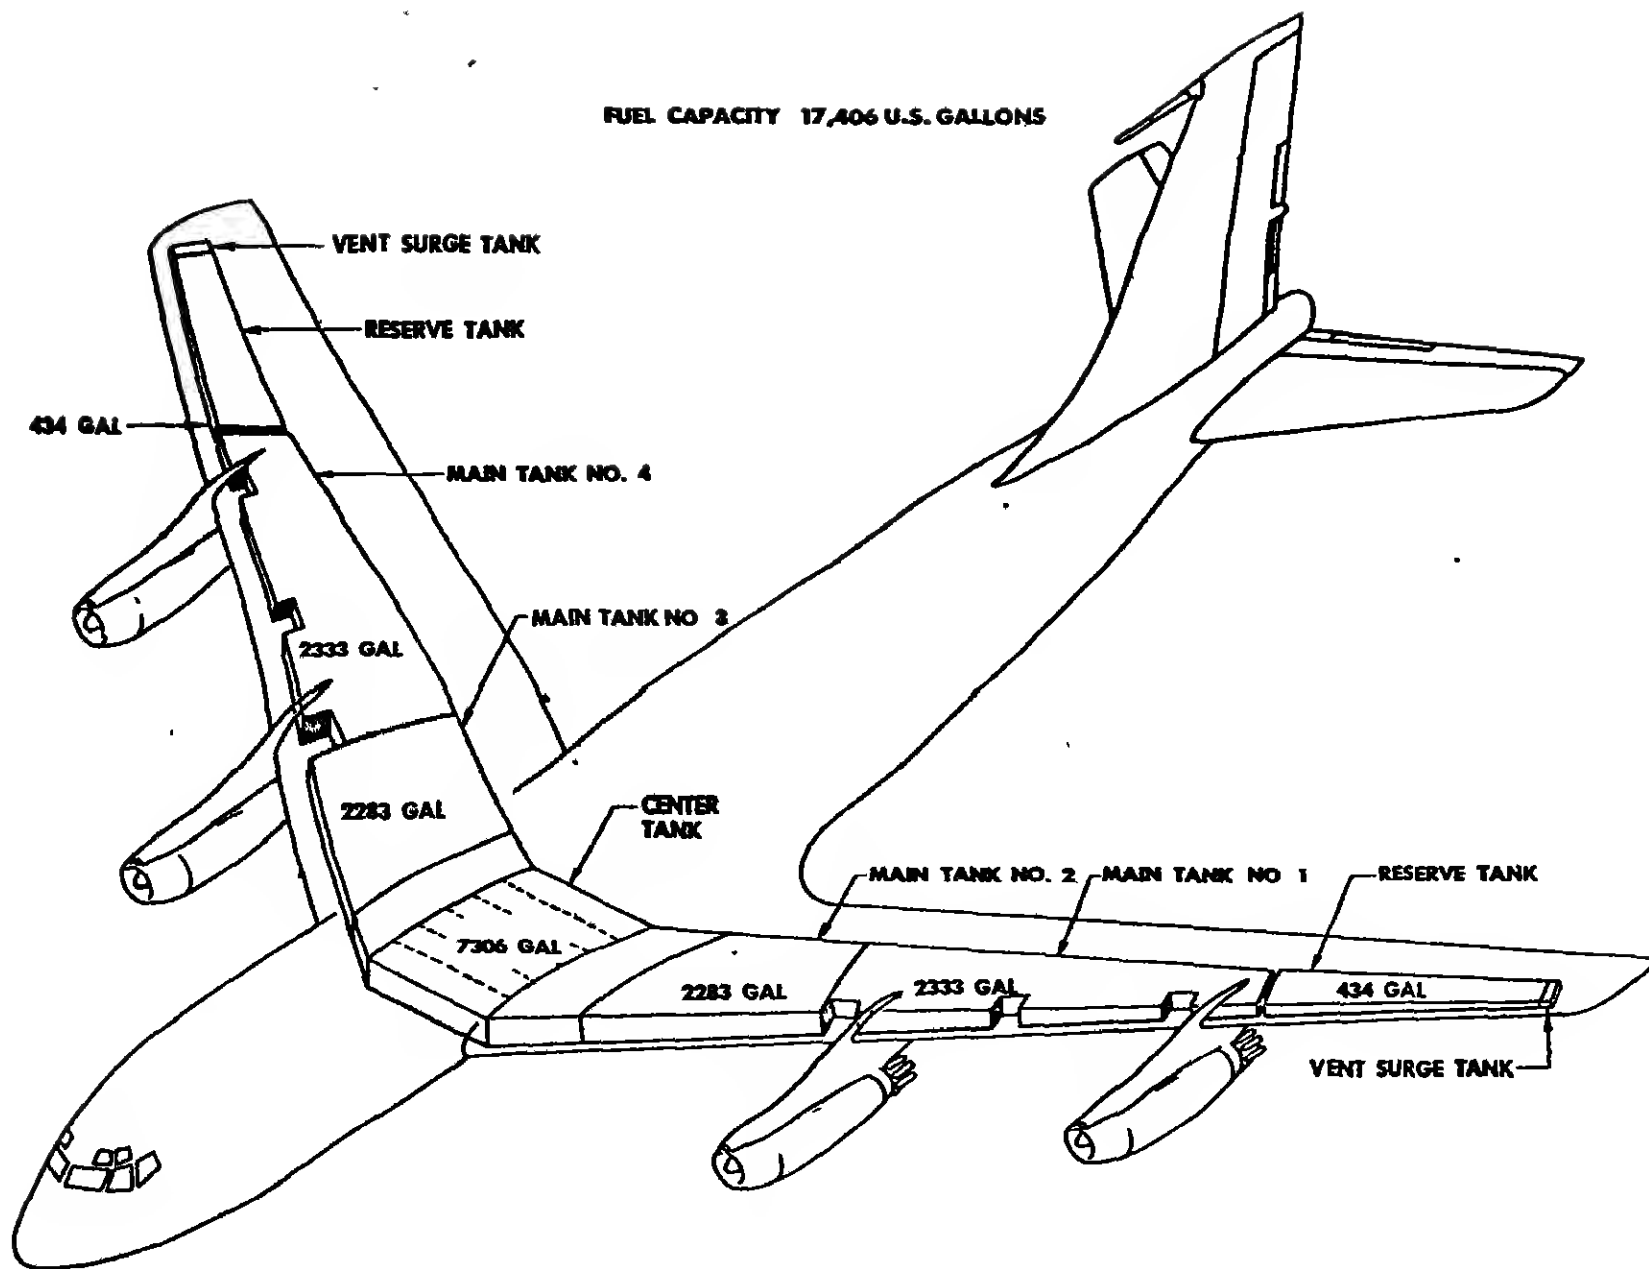
FUEL TANK ARRANGEMENT

The surge tank box^{7/} was intact except for a 2.2 inch opening along the top extending from spar to spar. This opening encompassed the surge tank end of the vent passages from the fuel tanks. The ends of the fracture curled up and were moderately sooted. The bottom surge tank skin was curled downward at a fracture line along the tank end closure rib. Very slight outward bulging of the tank end rib was noted. The interior of the surge tank was heavily sooted on all sides and the sealant was burned inside.
